OHIO RIVER BASIN
TRIBUTARY OF HARMON CREEK , WASHINGTON COUNTY

PA-484 DAM
NDI I.D. NO: PA-489
DER I.D. NO: 63-72

PHASE I INSPECTION REPORT
NATIONAL DAM INSPECTION PROGRAM

D'APPOLONIA CONSULTING ENGINEERS
10 DUFF ROAD
PITTSBURGH, PA. 15235

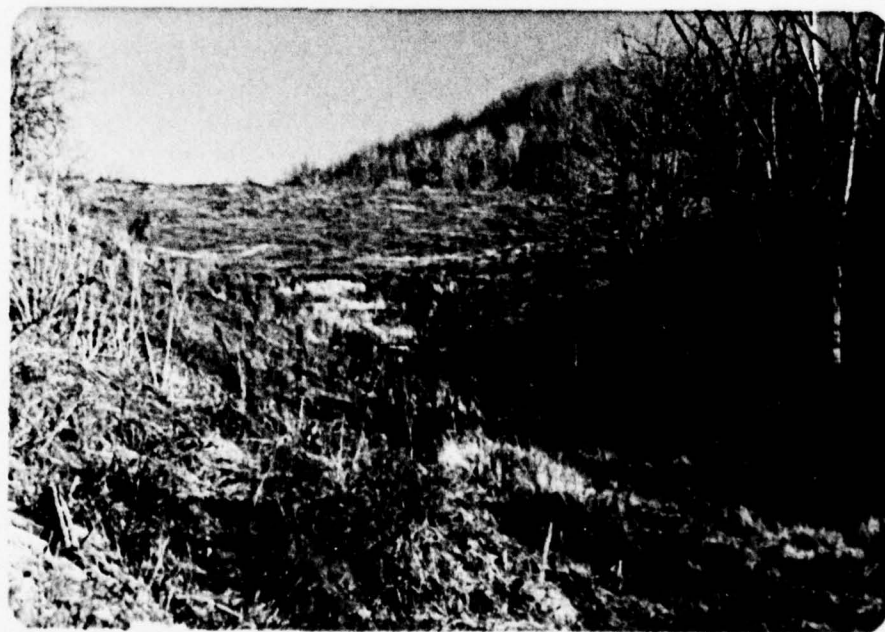
Downstream Face

The overall condition of the dam is considered to be fair. The portion of the downstream slope below the bench was found to be swampy with numerous seeps. The quantity of flow could not be estimated. Another swampy area was found below the toe of the dam near the right abutment. However, no seepage appeared to be associated with the swampy area. No signs of seepage were observed on the abutments or at the junction of the embankment and the abutments.

Although most of the embankment was found to be covered with grass and free of erosion problems, truck tracks on the downstream slope appear to be initiating erosion rills.

3.2 Evaluation. The condition of the dam is considered to be fair. The swampy area of the downstream slope of the embankment is considered to be significant relative to the overall stability of the embankment, but not serious at this time. No significant movements or sloughing was observed. However, it is considered advisable to instrument and monitor the seepage and reevaluate the stability of the embankment based on these observations. The erosion rills on the downstream slope of the dam should also be filled and vegetated to prevent future erosion problems.

4.5 Evaluation. The maintenance condition of the dam is considered to be satisfactory. However, the orifice in the drop inlet structure should be cleaned to permit lowering the reservoir to its normal elevation. The erosion rills in the truck tracks on the downstream slope of the dam should be filled and vegetated to prevent future erosion problems.

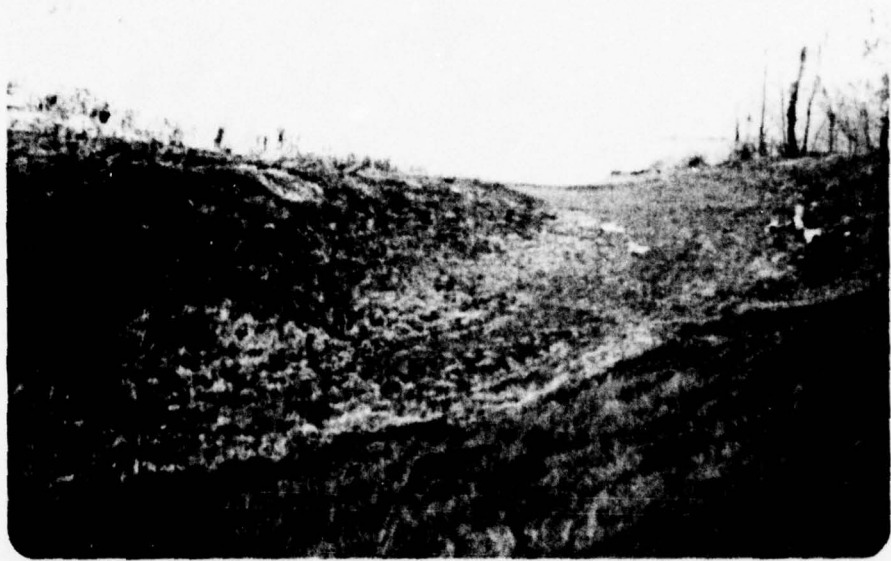
Photograph No. 1
Emergency spillway approach channel.

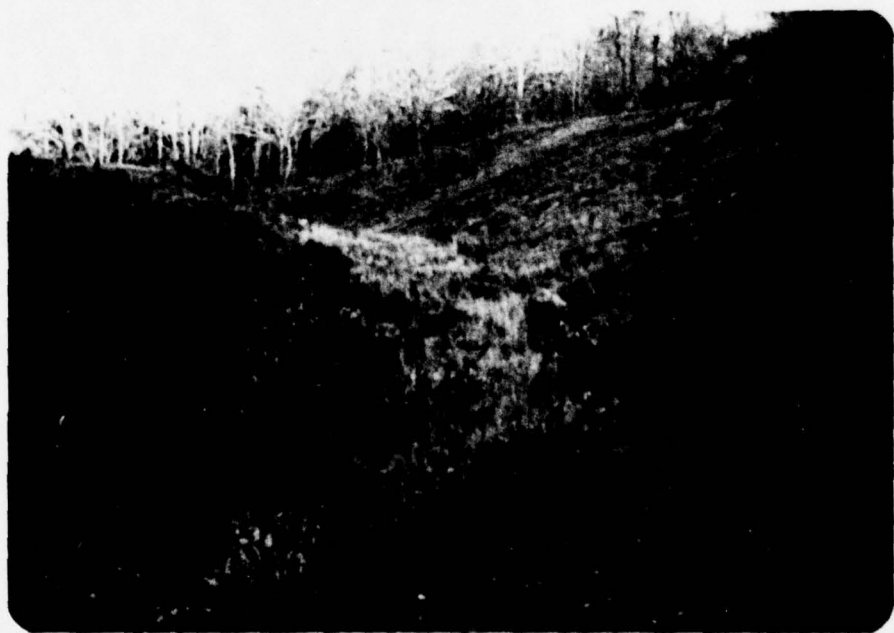
Photograph No. 2
Emergency spillway discharge channel.

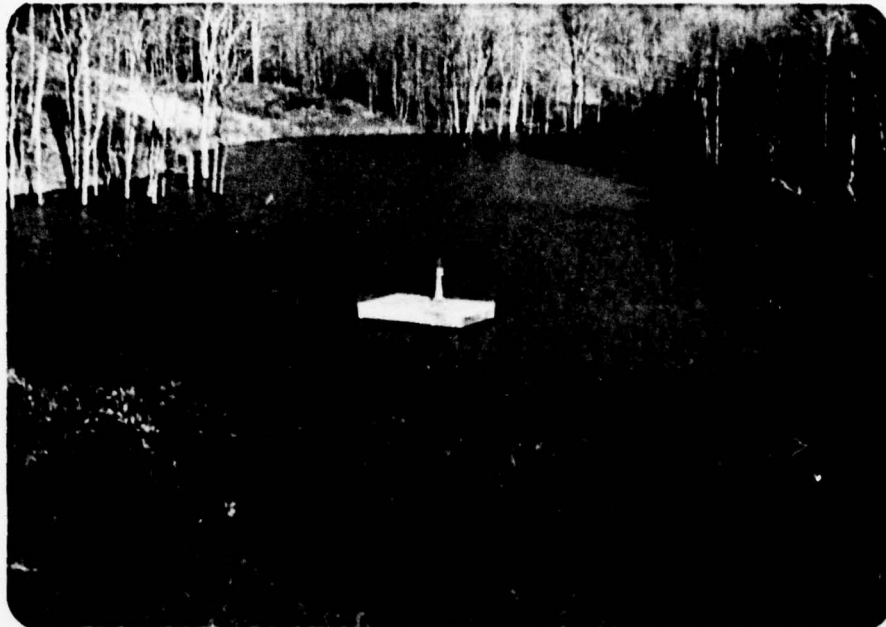
c. Appurtenant Structures. The appurtenant structures were examined for deterioration or other signs of distress or obstructions that would limit flow. On the date of inspection, the pool was approximately at the crest level of the primary spillway (Elevation 938.25),

indicating that the orifice of the drop inlet structure is obstructed. Other than this problem, the structures were found to be in good condition. No other deficiencies were noted at this time.

Photograph No. 3
Primary spillway drop inlet structure.

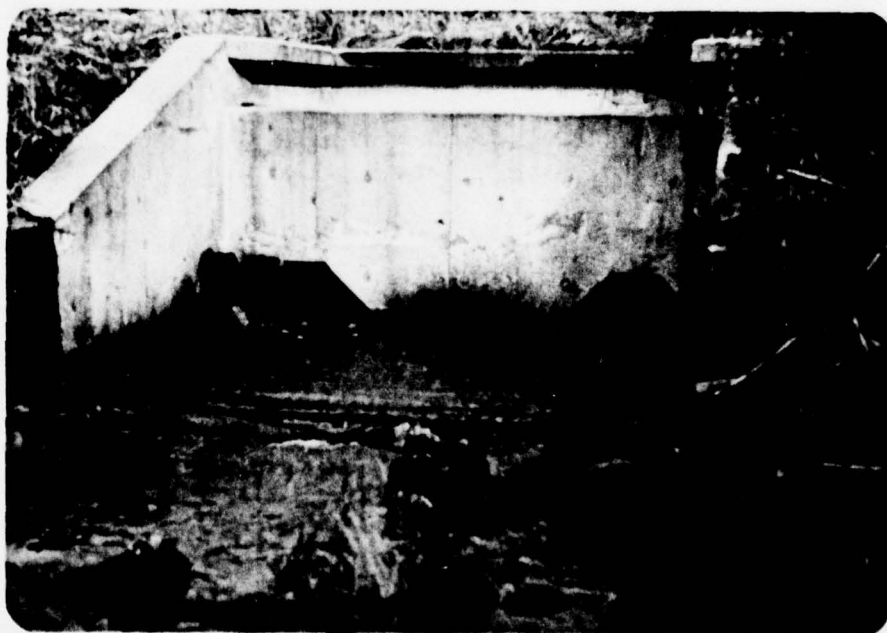
Photograph No. 4
Outlet pipe impact basin.
